4- UNITED STATES DEPARTMENT OF AGRICULTURE
SOIL CONSERVATION SERVICE RIO GRANDE DISTRICT
REGION EIGHT - RIO GRANDE SURVEY

REPORT ON
SURVEYS, EXAMINATIONS, AND INVESTIGATIONS
MADE NEAR SAN MARCIAL, NEW MEXICO
DURING 1936, 1937, and 1938

Subject: Siltation Conditions in and near
San Marcial, New Mexico, - 1936-38

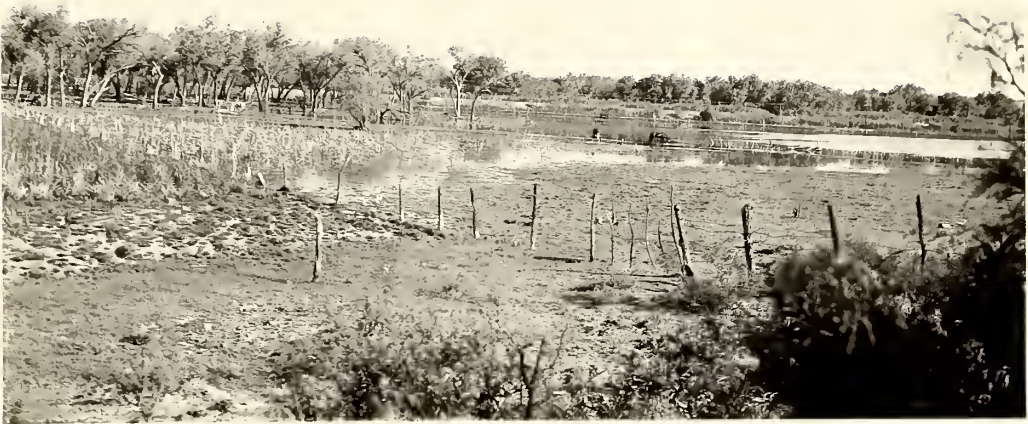
San Marcial. Line 5. Looking northeast from old road below 5 W.

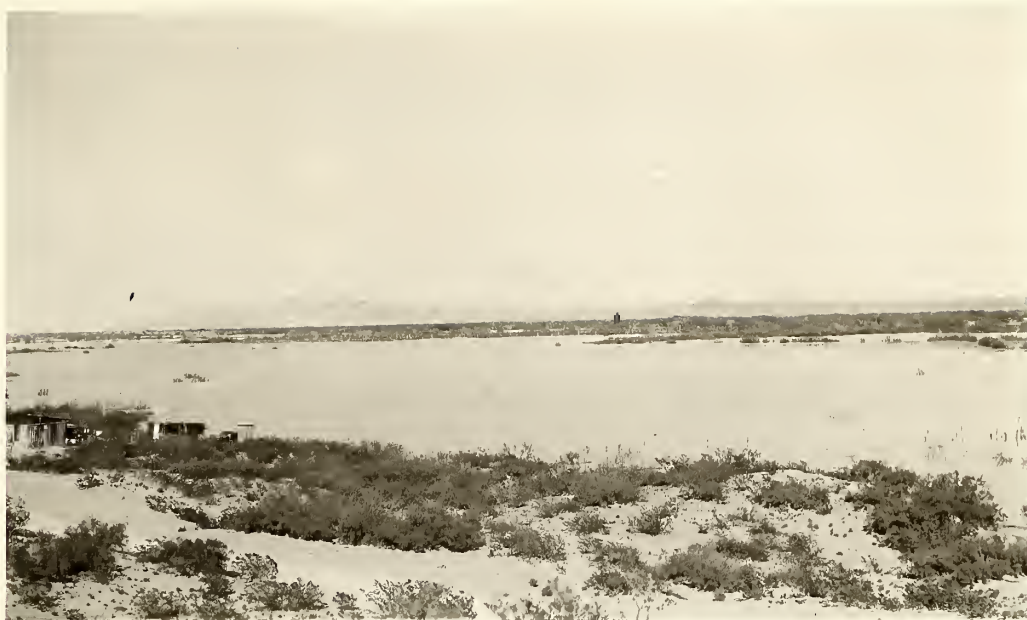
San Marcial. Looking northeasterly from triangulation station San Geronimo. Val Verde Mountains in left background and water works near center.

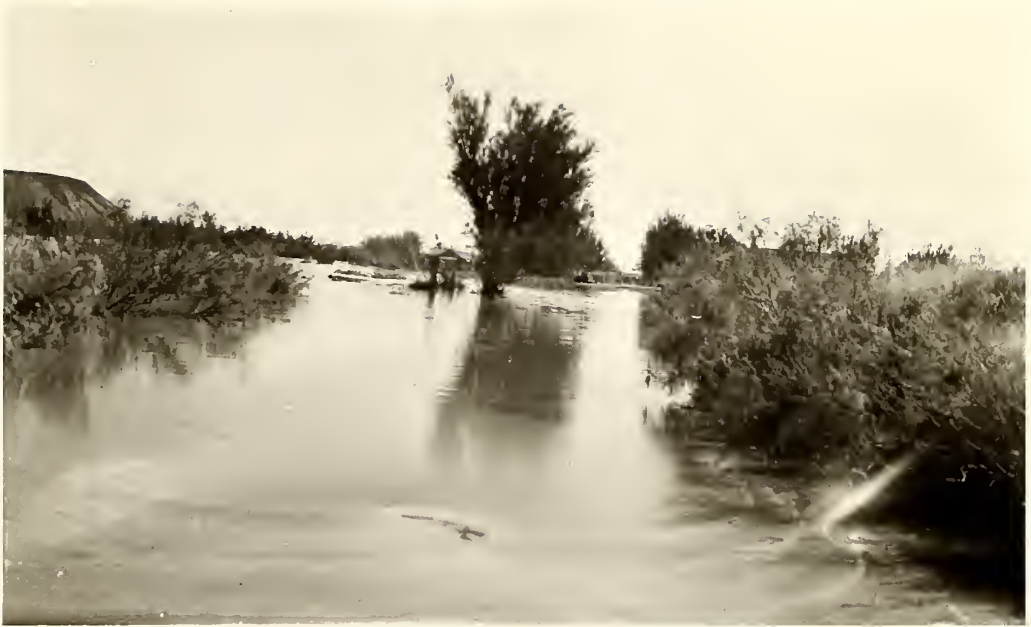
San Marcial. Looking southerly along Old Town road.

An examination of Old Town San Marcial showed that about ten houses had fallen during the past two weeks. The water was standing within 0.5 foot of the top of the concrete foundation of the Catholic Church and waves had been high enough to wet the adobes on top of the concrete. No precautions had been taken to prevent the waves getting to the adobe bricks.

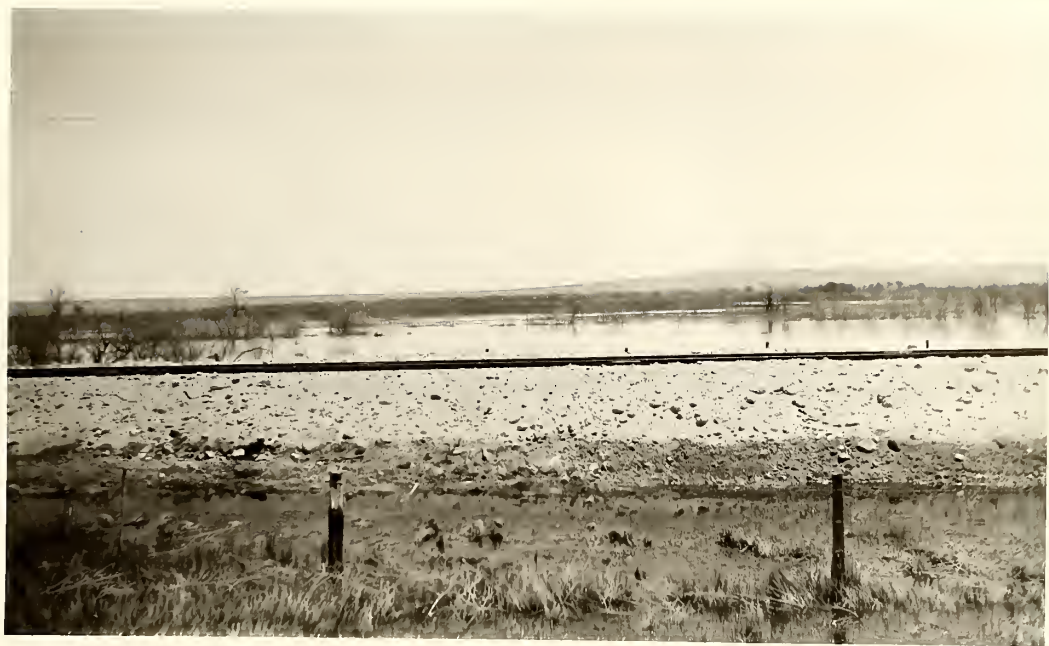
Rio Grande Valley. Valley cross section. Line 997. Biological Survey.

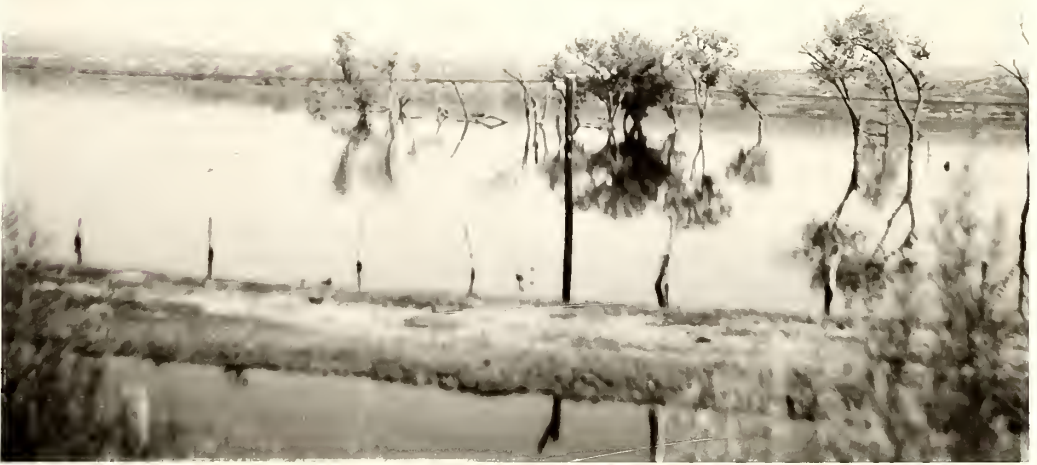
Rio Grande Valley. Looking westerly from Railway track on Line F.

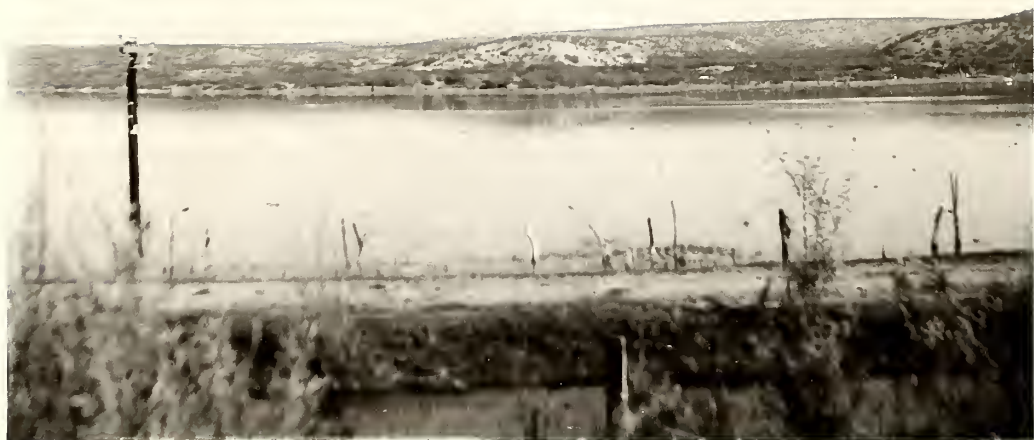
Rio Grande Valley. Line 5. Looking westerly from track of the A. T. & S. F. Railway toward 5 W.

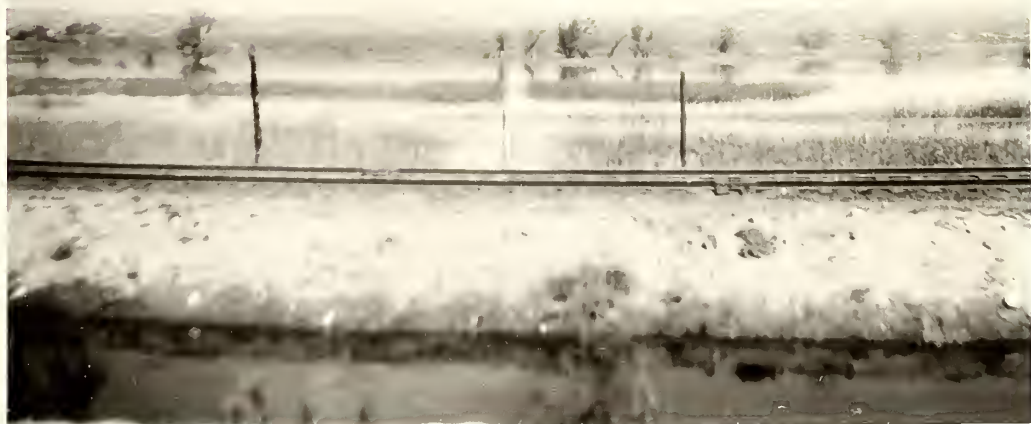
Rio Grande Valley. Line E. Looking westerly from switch track of Railway. Elevation of water about 4464.2.

I noted that the Railway Company in the last three weeks have dumped from one to four feet of gravel on the east side of the track from near mile post 1004 to mile post 1006, and in places the water would have overflowed the track if the material had not been so deposited.

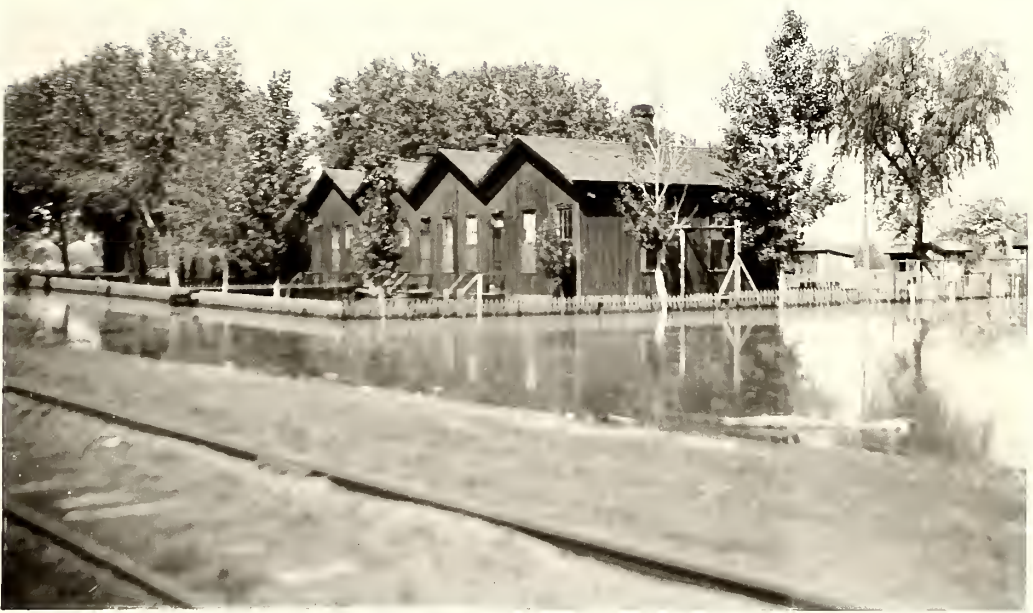
San Marcial. Houses of the A. T. & S. F. Railway. Elevation of water about 4464.2.

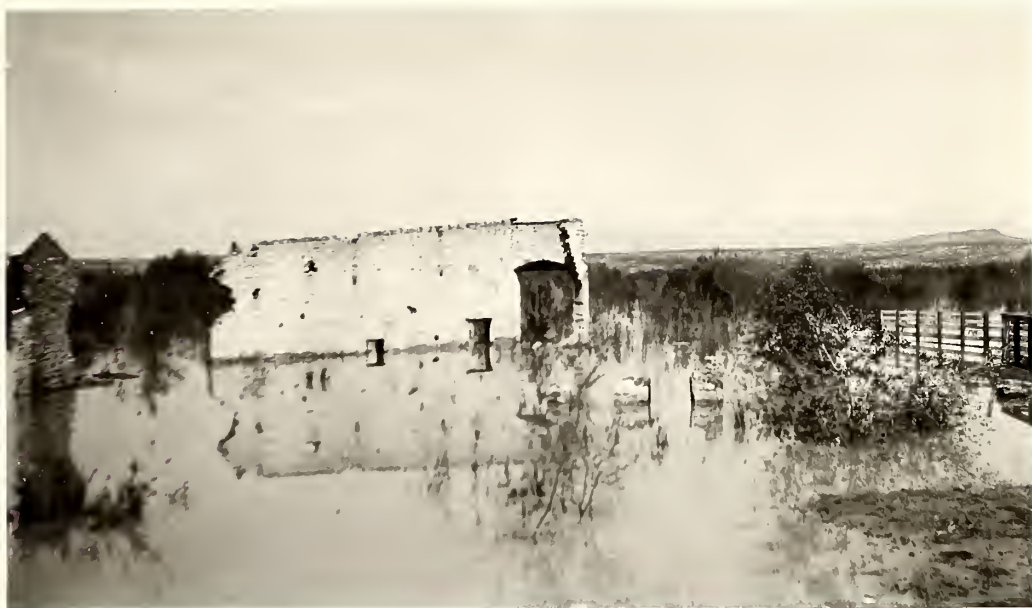
San Marcial. Ruins of old Round House. Looking west from Railway track. Part of stock shipping yards in extreme right.

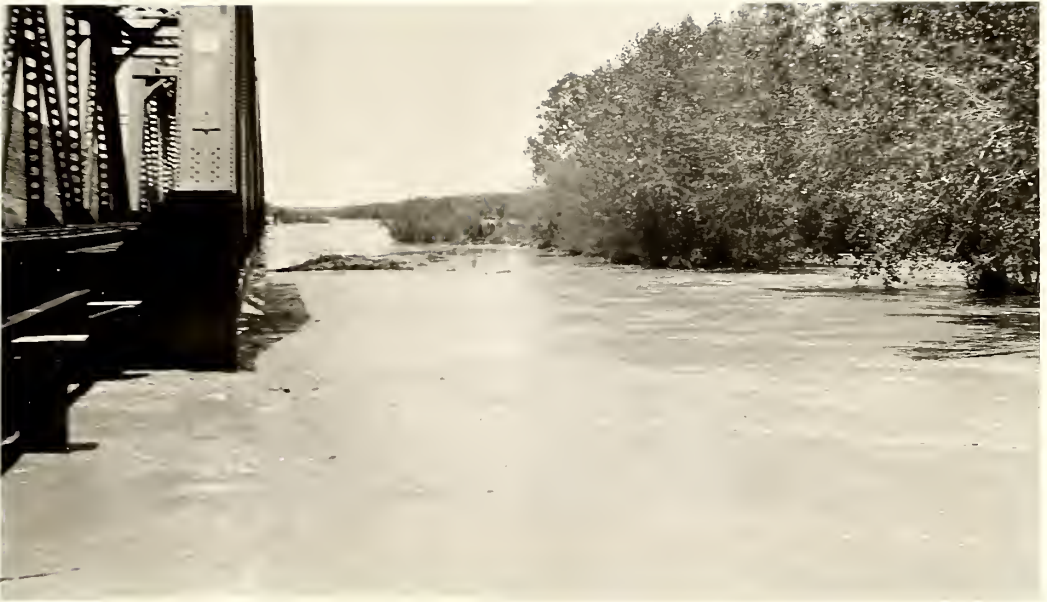
San Marcial. Looking south along west side of bridge of the A. T.
& S. F. Railway.

I noticed a peculiar condition on the upper side of the bridge. The surface water seemed to be comparatively clear yet boils which would bring sand and silt to near the surface occurred due to the obstruction of the bridge piers. This was something that I had never seen before at this site or any other place. It was evident that the deposition of silt below the railway bridge was causing a rise in the stream channel and water surface. A large percentage of the water flowing under the bridge was still flowing northwesterly towards San Marcial.

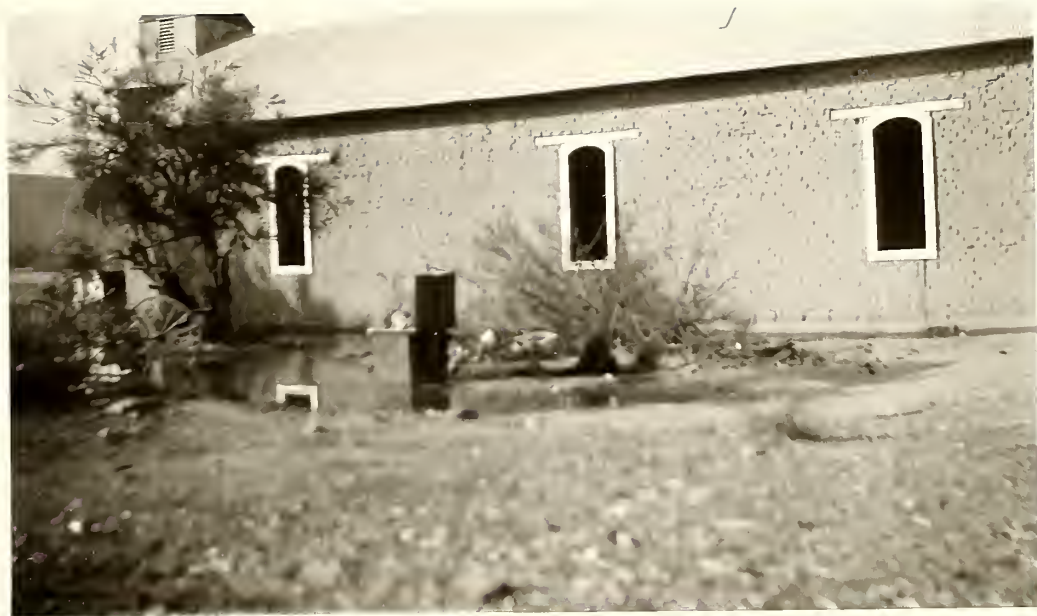
San Marcial. North side of Catholic Church at Old Town. Water half foot below top of concrete.

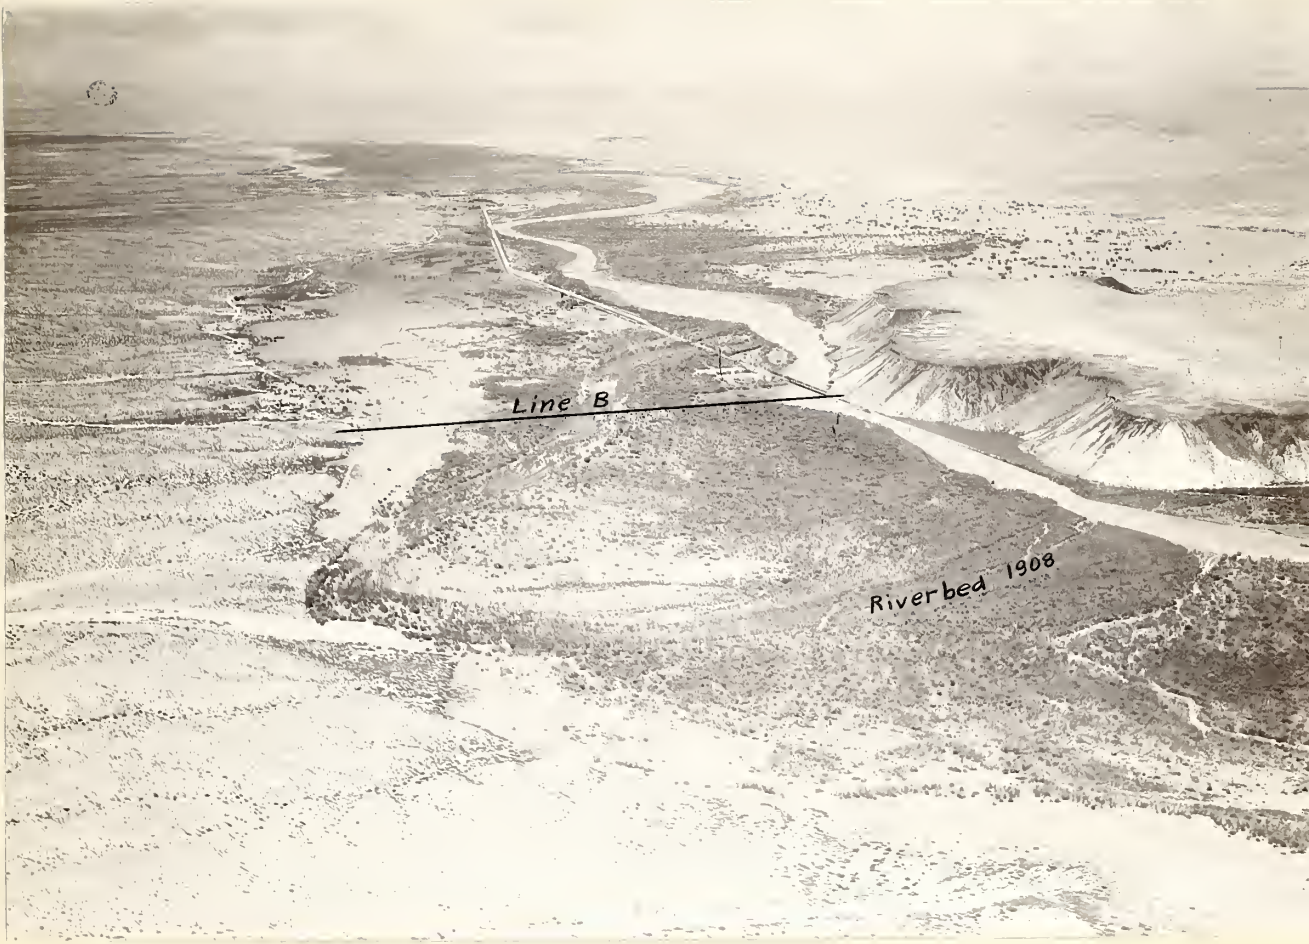
Looking northerly up the upper end of the Elephant Butte Reservoir and the Rio Grande Valley. The flooded area of San Marcial is to the left of the center and the return flow therefrom is in the right foreground. The Black Mesa and the flooded area near Val Verde are at the right. The bridge of the A. T. & S. F. Railway and the San Marcial highway bridge are discernible. The channel prior to the avulsion of 1920 is shown by the vegetation near the center. May 27, 1937, by E. D. Eaton.

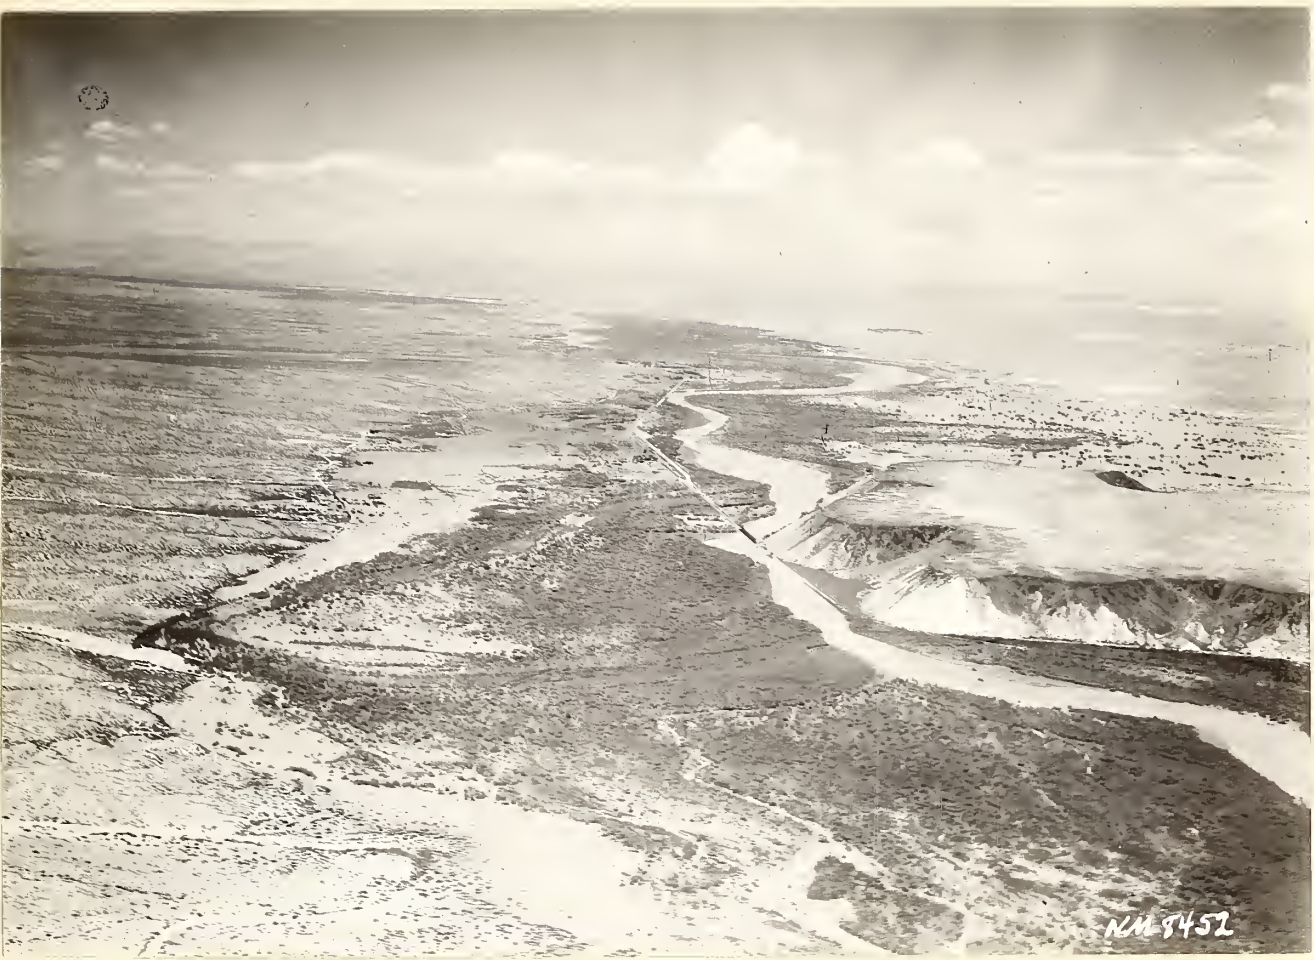
Looking northerly up the upper part of the Elephant Butte Reservoir and up the Rio Grande Valley. Flooded area near San Marcial and return flow therfrom along the west edge of the valley and reservoir. Upper end of reservoir near railway bridge. Black Mesa at right and flooded area at Val Verde beyond. Old channel prior to avulsion of 1920 shown by vegetation near center. May 27, 1937, by E. D. Eaton.

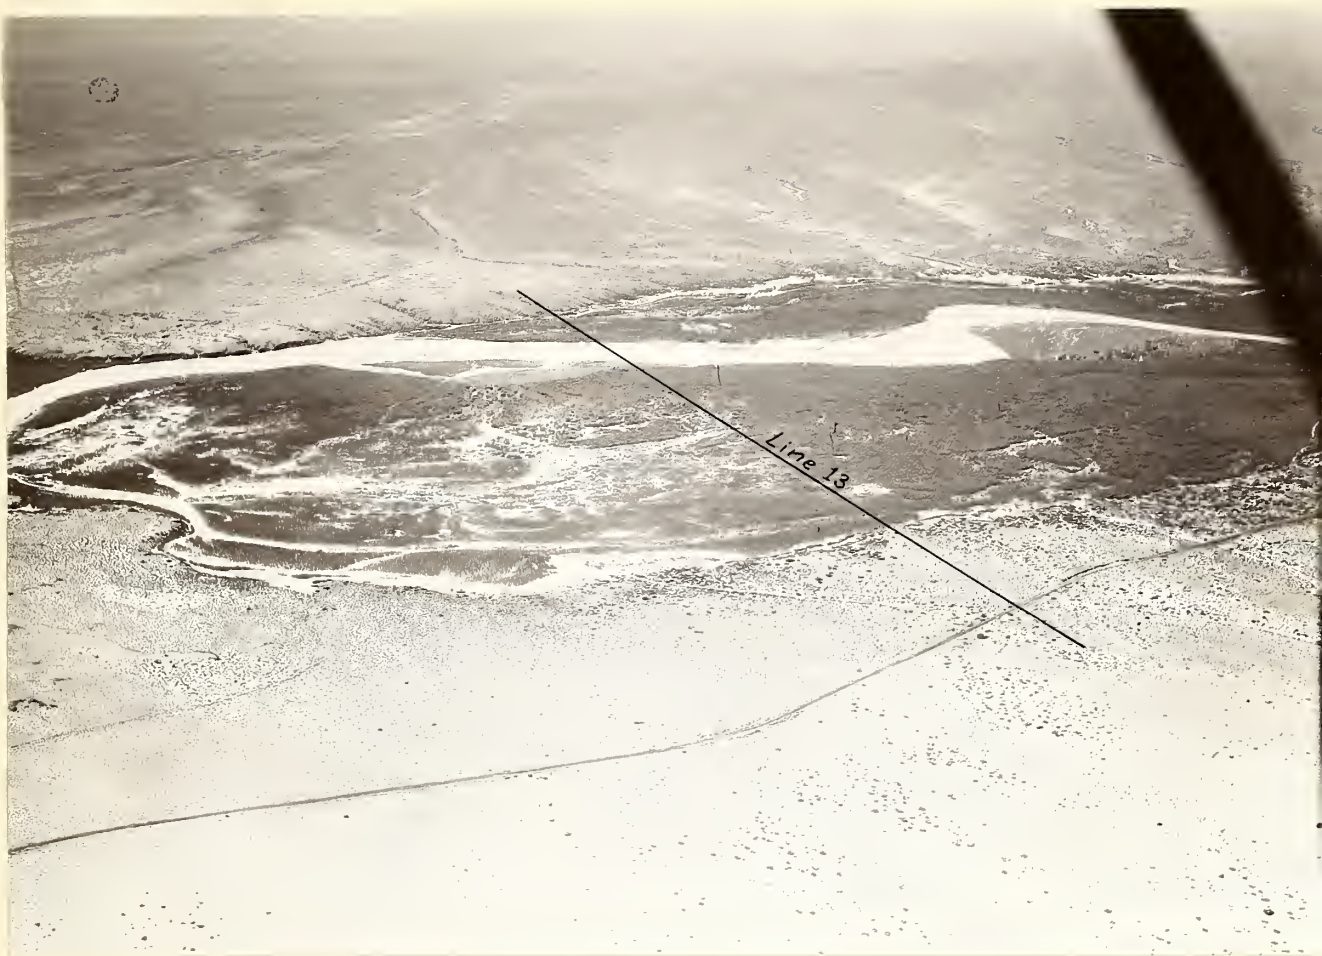
Looking westerly across part of upper end of Elephant Butte Reservoir about five miles below San Marcial. A. T. & S. F. Railway in foreground. Old Fort Craig near left edge and west of the river. Return flow from San Marcial is west of river and next to mesa. Overflow from river below railway bridge on east side of river. May 27, 1937, by E. D. Eaton.
